February 18, 2021

Version 1

Warranty Extension: 2019-20 Passport/Pilot MOST Bus Network Connectors

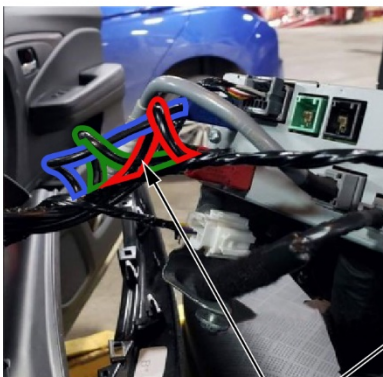
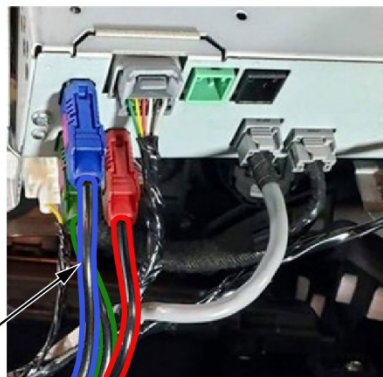
HARNESS
Reroute.

23. Install all of the removed parts in the reverse order of removal. When installing units, make sure the harness is routed correctly because a misrouted harness can put pressure on the connectors, which can cause a connection issue. Do not pull on the units or MOST service cords while the FAKRA connectors are connected to help prevent communication issues.

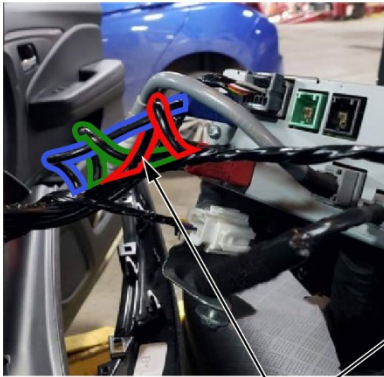
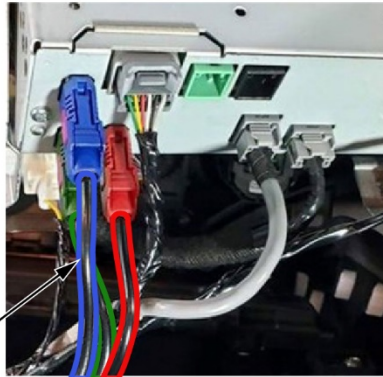
**HARNESS
Reroute.**

28. Install all of the removed parts in the reverse order of removal. When installing units, make sure the harness is routed correctly, as a misrouted harness can put pressure on the connectors, which may cause a connection issue. Do not pull on the units or MOST service cords while the FAKRA connectors are connected to help prevent communication issues.
