Warranty Extension: 2018-20 Odyssey MOST Bus Network Connectors**AFFECTED VEHICLES**

BACKGROUND

A loose connection in the MOST bus network is causing a popping or crackling from the speakers or no sound from the audio system. There may also be a Network Loss message and/or display issues.

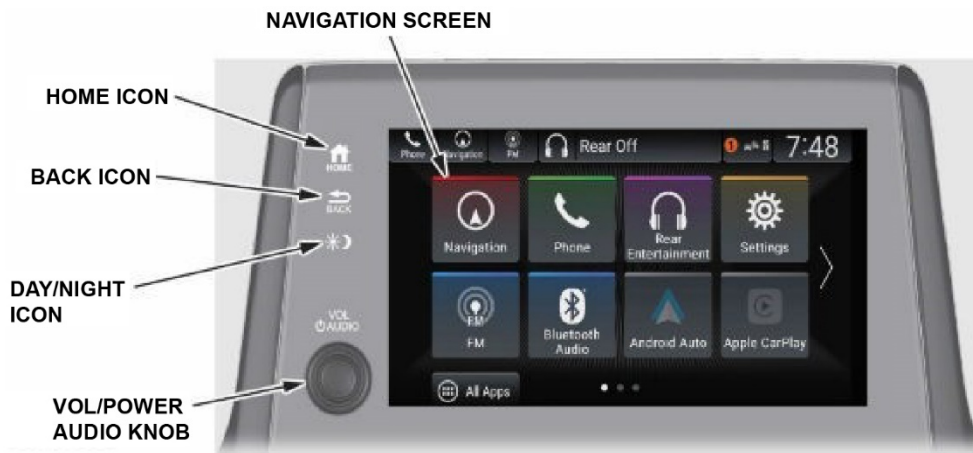
1. Turn the ignition to ON.
2. Press and hold the VOL/Power AUDIO knob, **Day/Night** icon, and **HOME** icon at the same time. Then, release them when you see the **Dealer Diagnostics** screen.

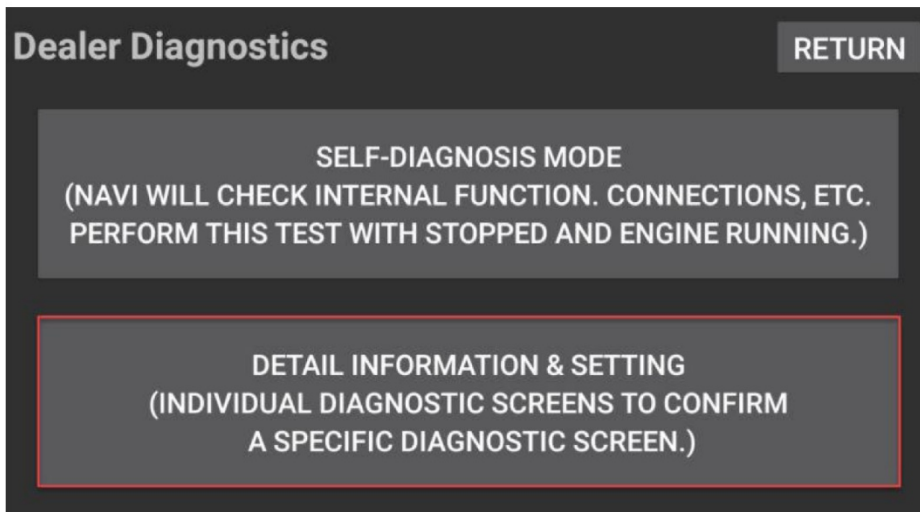
3. Select **DETAIL INFORMATION & SETTING**.

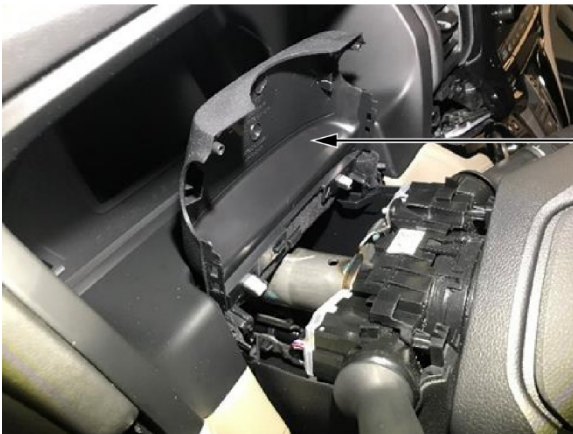
UPPER
COLUMN
COVER

2. Loosen the upper column cover.

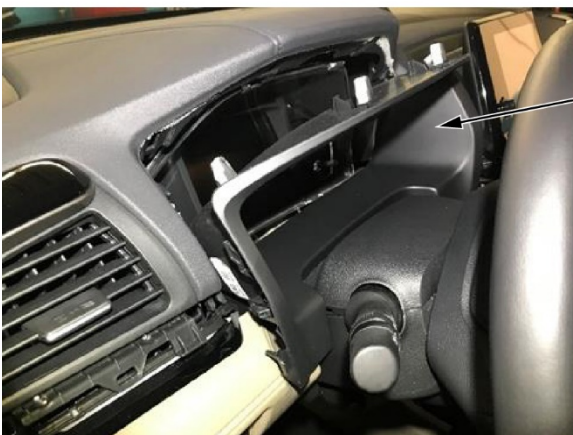
METER
BEZEL

3. Disengage the clips around the meter bezel. Then, remove it with the upper column cover as one piece.

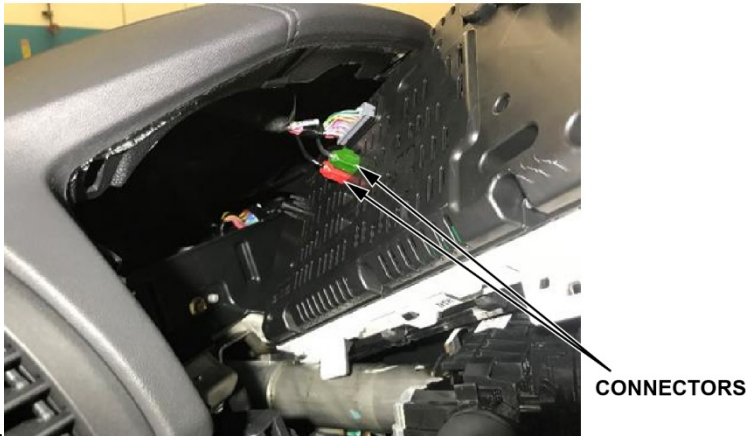
5. Turn the gauge control module to access the rear connectors. Then, using the straight FAKRA tool, disconnect the red and green FAKRA connectors, and remove them from the gauge control module. Do not pull on the units while the FAKRA connectors are connected to help prevent communication issues.

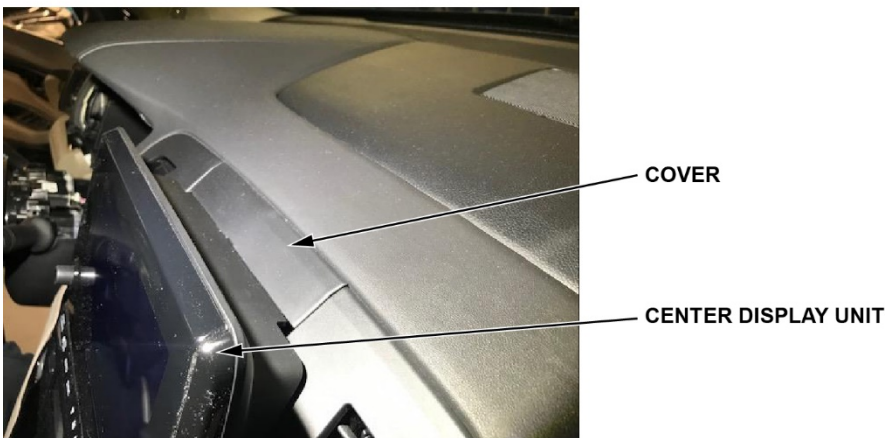
6. Remove the cover above the center display unit.

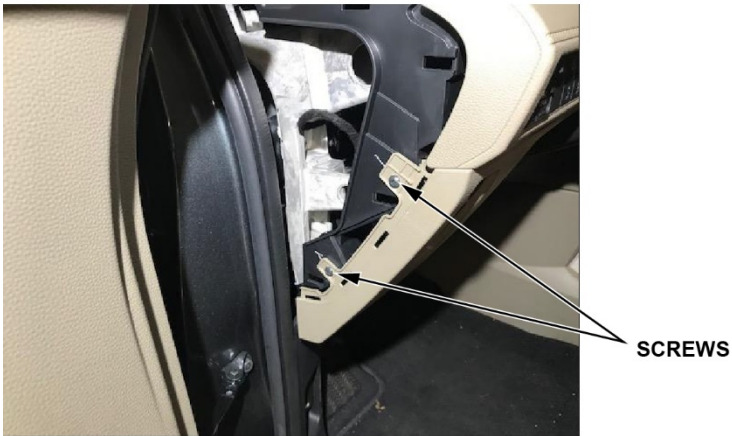
10. Remove the two screws.

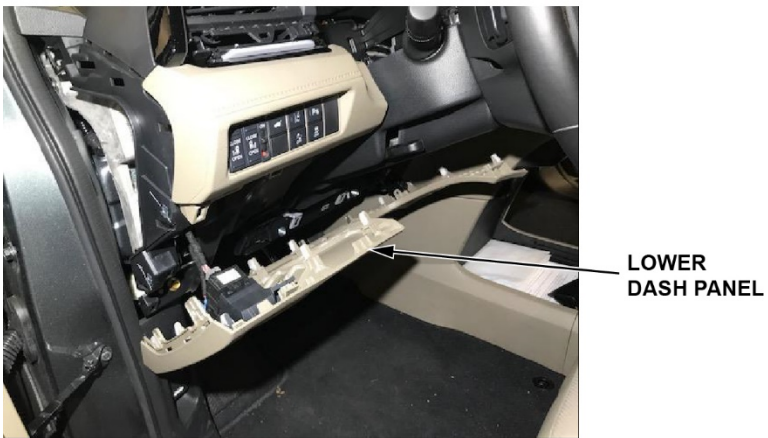
11. Remove the lower dash panel.

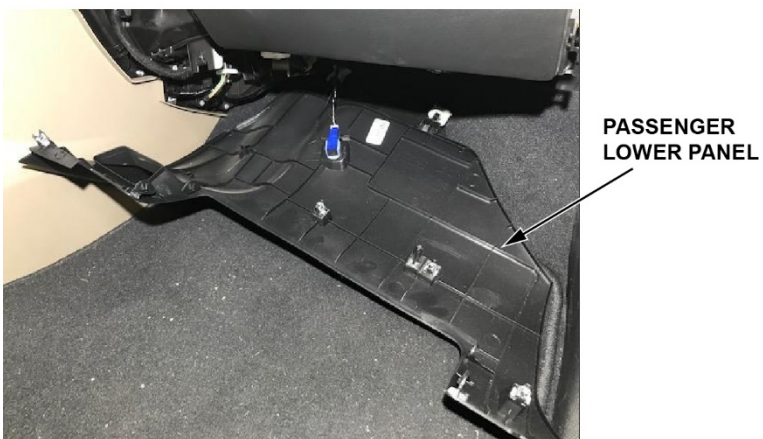
12. Remove the passenger lower panel.

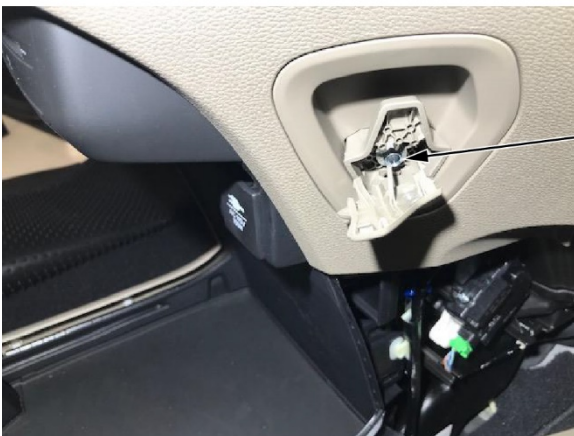
BOLT

14. Pull back the cover, and remove the bolt.

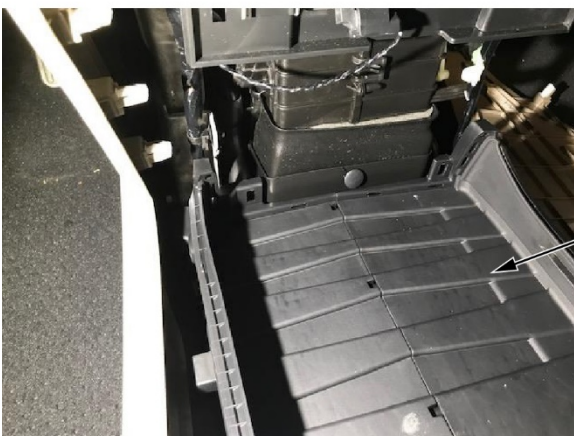
**RUBBER
LINER**

15. Remove the rubber liner, and pull back the lower console cover.

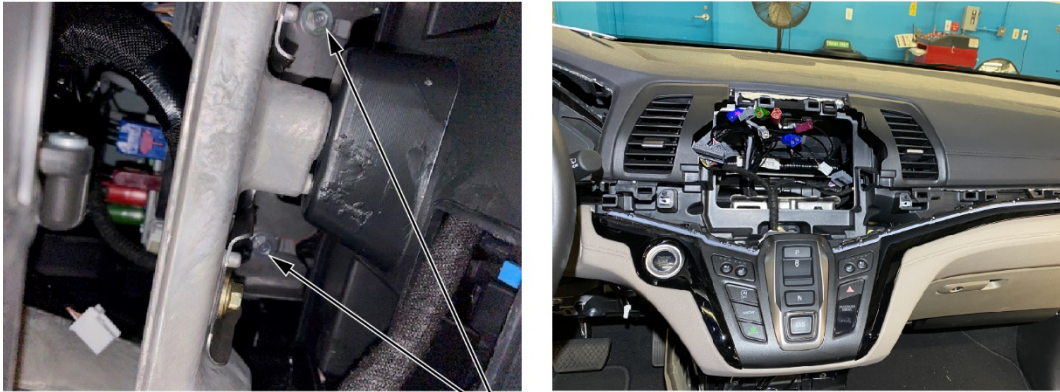
BOLTS

19. While looking upward from underneath where the DVD player, CD player, or center pocket was removed, loosen the two 8 mm bolts holding the infotainment unit, then remove the unit.

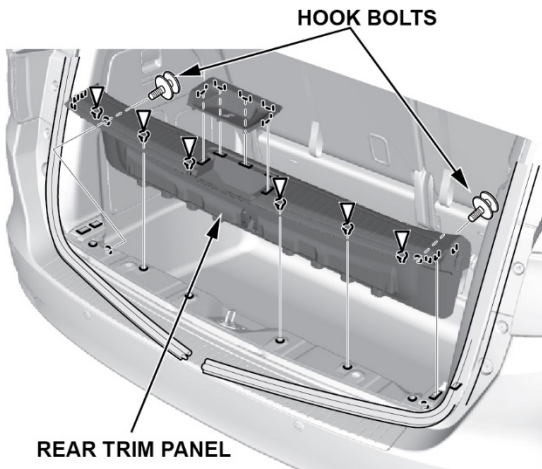
20. In the rear cargo area, remove the rear trim panel.

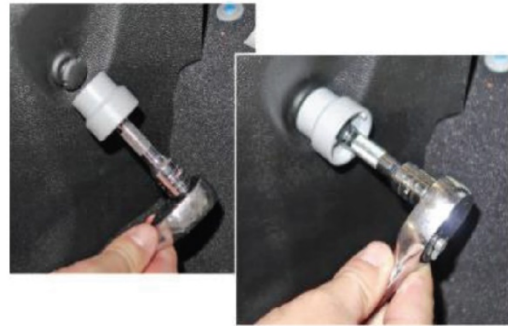
If necessary, use Special Tool 07AAA-SEPA100 to loosen the hook bolts.

21. On the right rear quarter panel, remove the hook bolts. If needed, use Cargo Cap Screw Socket (T/N 07AAA-SEPA100) to loosen the bolts.

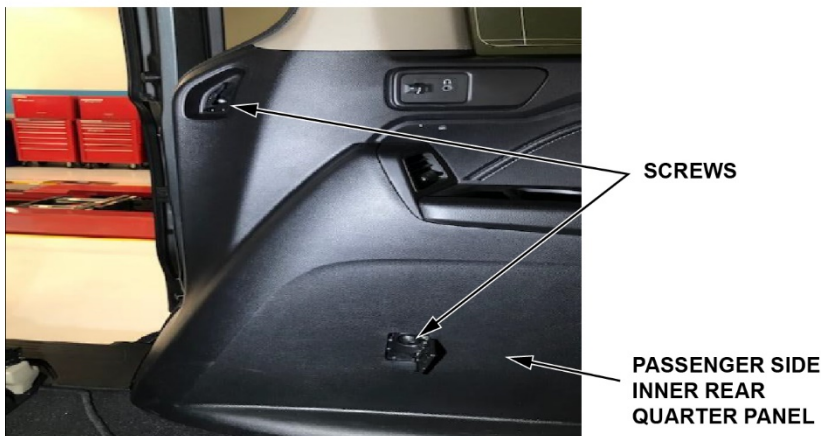
22. Remove the covers then remove the two screws from the passenger side inner rear quarter panel.

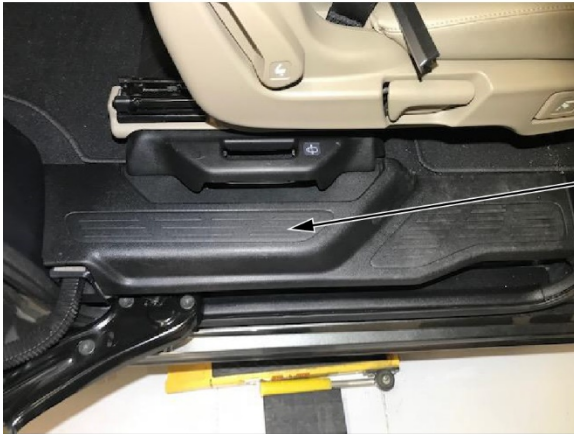
**LOWER PASSENGER
SLIDING DOOR TRIM**

23. Remove the lower passenger sliding door trim.

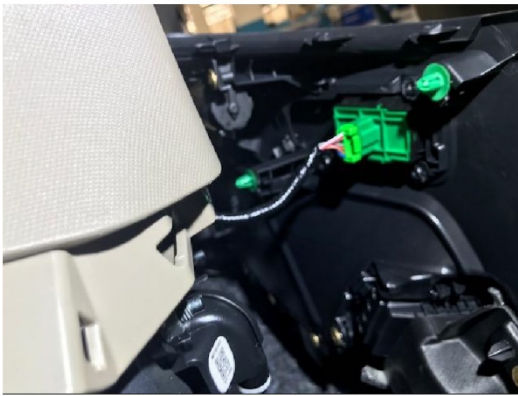
RIGHT QUARTER INNER PANEL

24. Remove the right quarter inner panel, then disconnect the connectors.

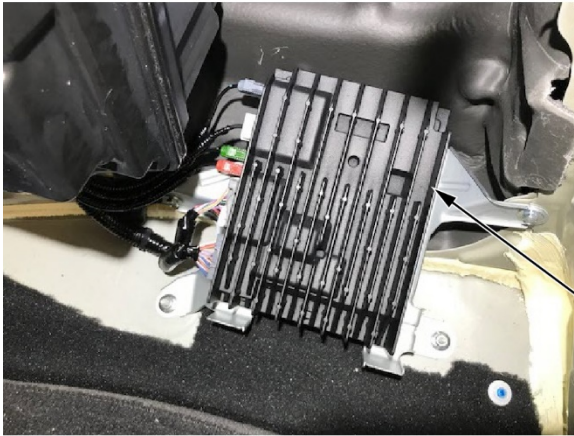
**STEREO AMPLIFIER OR
TUNER-AMPLIFIER**

25. Disconnect the red and green FAKRA connectors from the stereo amplifier (Elite) or tuner-amplifier unit (EX, EX-L, Touring), gauge control module, and infotainment unit using the straight FAKRA puller. Do not pull on the units while the FAKRA connectors are connected to help prevent communication issues.

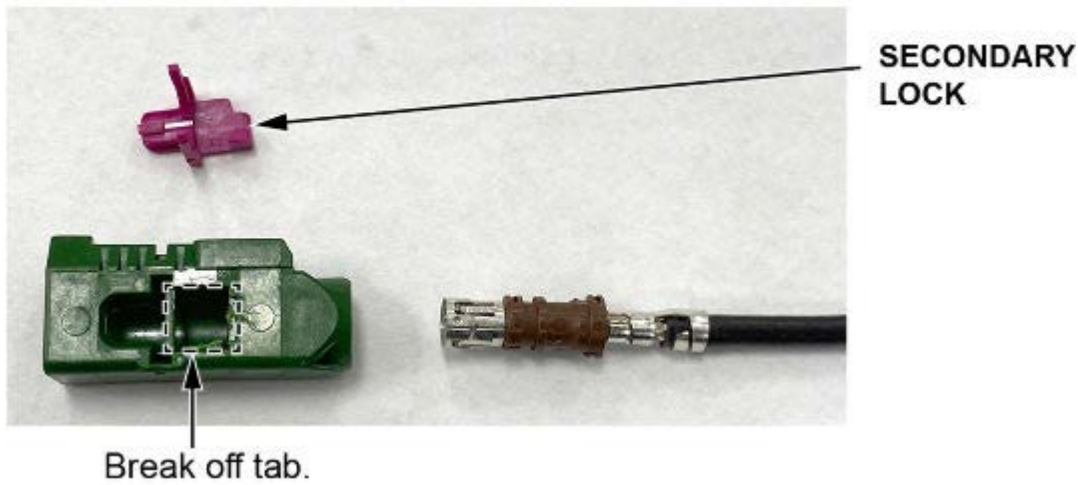
26. Using a small screwdriver, remove the secondary lock, then break off the tab as shown. Then, discard the housing and lock.

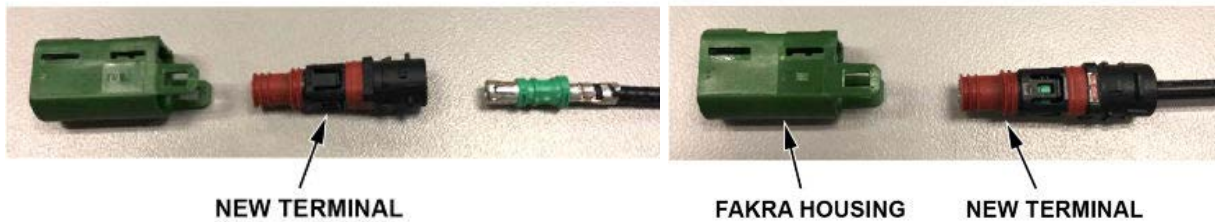
27. Pull and twist the housing counterclockwise to remove it from the wire.
28. Select the correct color FAKRA housing, then slide the new terminal onto the wire until it clicks into place.

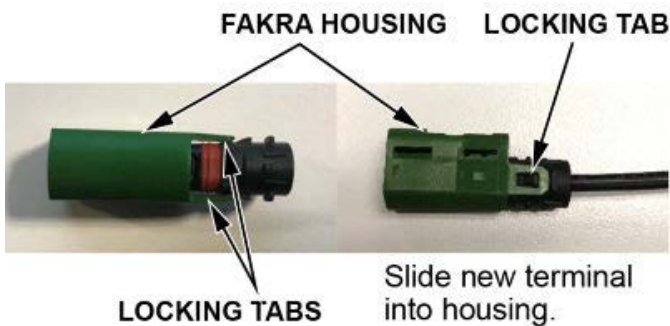
29. Line up the locking tabs on the FAKRA housing with the new terminal, then push the terminal into the housing until it clicks into place.

30. Repeat steps 26 thru 29 for the other connectors. Then, install the FAKRA connectors to the gauge control module, infotainment unit, and stereo amplifier or tuner-amplifier unit.
